<b>Reference Bulletins:</b>	<b>Subject:</b>	<b>Product</b>
SB 81-102; Aug. 1988	<b>SUNROOF</b>	<b>CARS</b>
	200	<b>Group</b>
	ALL	83
	<b>Date:</b>	<b>No.</b>
	AUGUST 1989	201

THIS BULLETIN APPLIES TO THE U.S. AND CANADA  
REFERENCE: TP 31120/1 (ENGLISH); BODY

Leakage from the left and right guide rails, and the two front rails, can be corrected using the following procedure. (To remedy the situation, the sunroof and guide rails must be removed.)  
The sealers to be used are butyl tape (P/N 1277872-6), plastic filler (P/N 1161123-3), and body filler (P/N 277253-1).

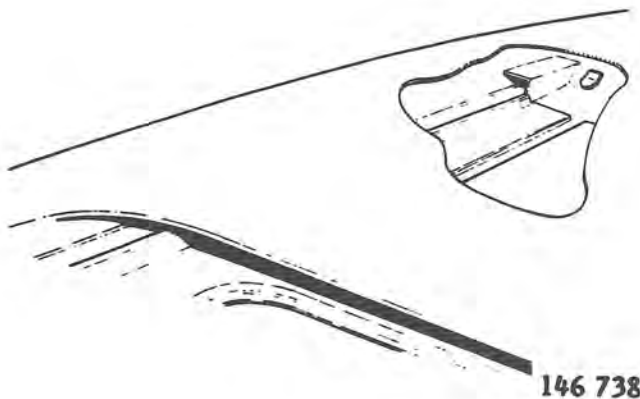
**Note:** Guide rails may be stuck in place due to butyl tape in drain channel.

**Important:** Carefully remove all butyl tape remaining in guide rails

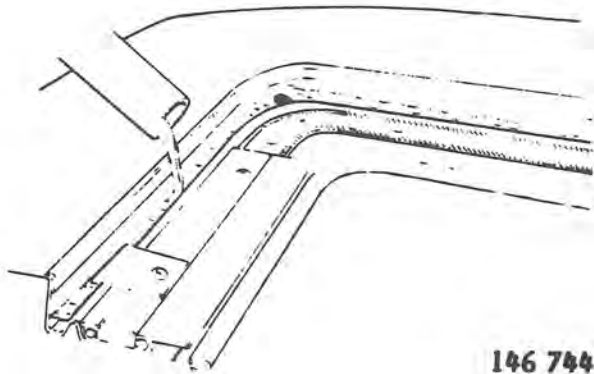
146 744

Check that no leakage occurs at splash guards

Plug holes for both front drain holes. Clamp both rear drain hoses. Pour water in channels on base plate. Check that no water runs past rear section of guide rails and into car.
