## Jon Stopford-Collins recalls the challenge of restoring his award-winning Volvo 164

# TRANSFORMATION

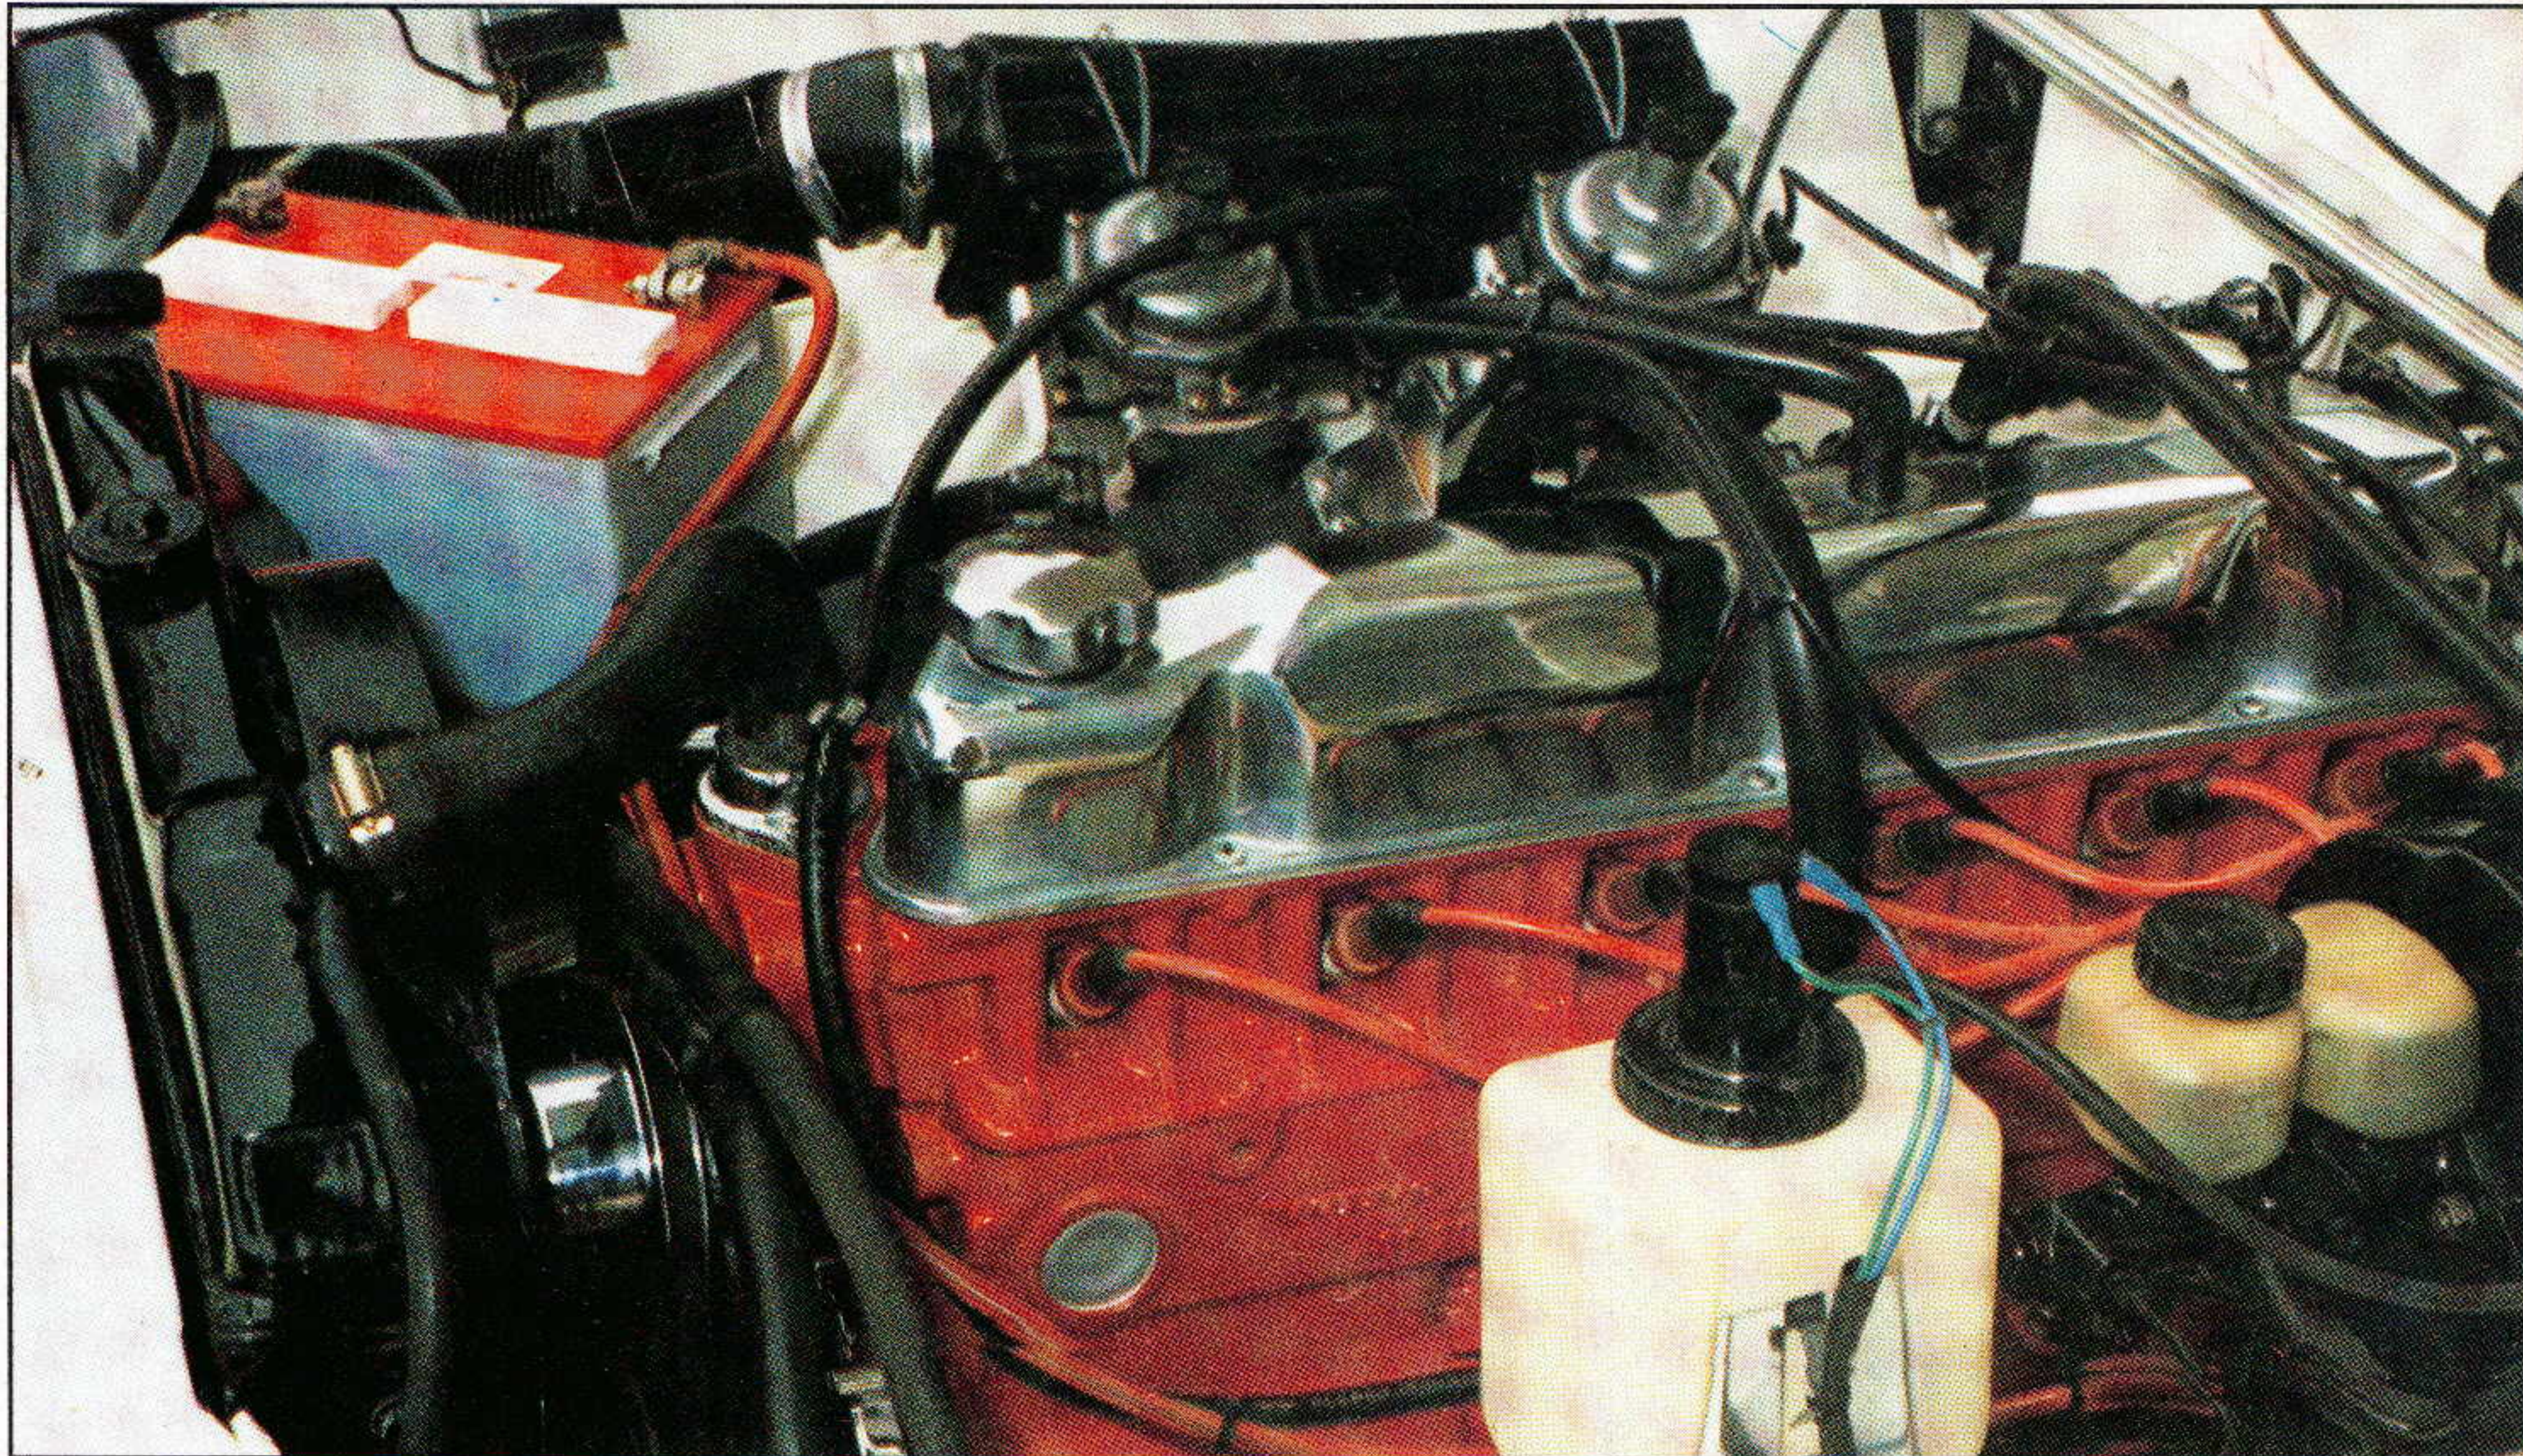
*Above, the engine bay of Jon Stopford-Collins' Volvo; smart but not over-restored*

I then decided that whilst the bonnet and wings were removed I would take the opportunity to re-finish the engine compartment. The carburettors, inlet and exhaust manifold, the radiator, brake-servo, coolant expansion bottle and power steering reservoir were removed. This greatly improved access to the inner wings and front panel.

I did, however, want to re-spray the bulk-head, so to 'kill two birds with one stone' I removed the cylinder head as this would allow much more working space. It also enabled me to carry out a 'de-coke' and check the camshaft, as the engine had developed a slight rattle which was thought to be wear in this area. This assumption proved correct as there was a loss of profile and pitting in the case-hardening; so a new camshaft and twelve followers were fitted.

Next the old engine lacquer was stripped off, then the block and head were repainted with Hermetite red which is a good match for the original colour. I also stripped the starter-motor and power-steering pump, these were re-finished with black Hermetite and the alternator was repainted silver-grey. The servo was also stripped, but this I thought would look better sprayed rather than brush painted black. All the wiring was cleaned as were the relays and terminals. The grommets were removed from the bulkhead and everything was masked ready for spraying. With access to the bodywork surrounding the engine clear, I started to 'flat' the paintwork with 400 grade wet & dry, then de-greased. Three

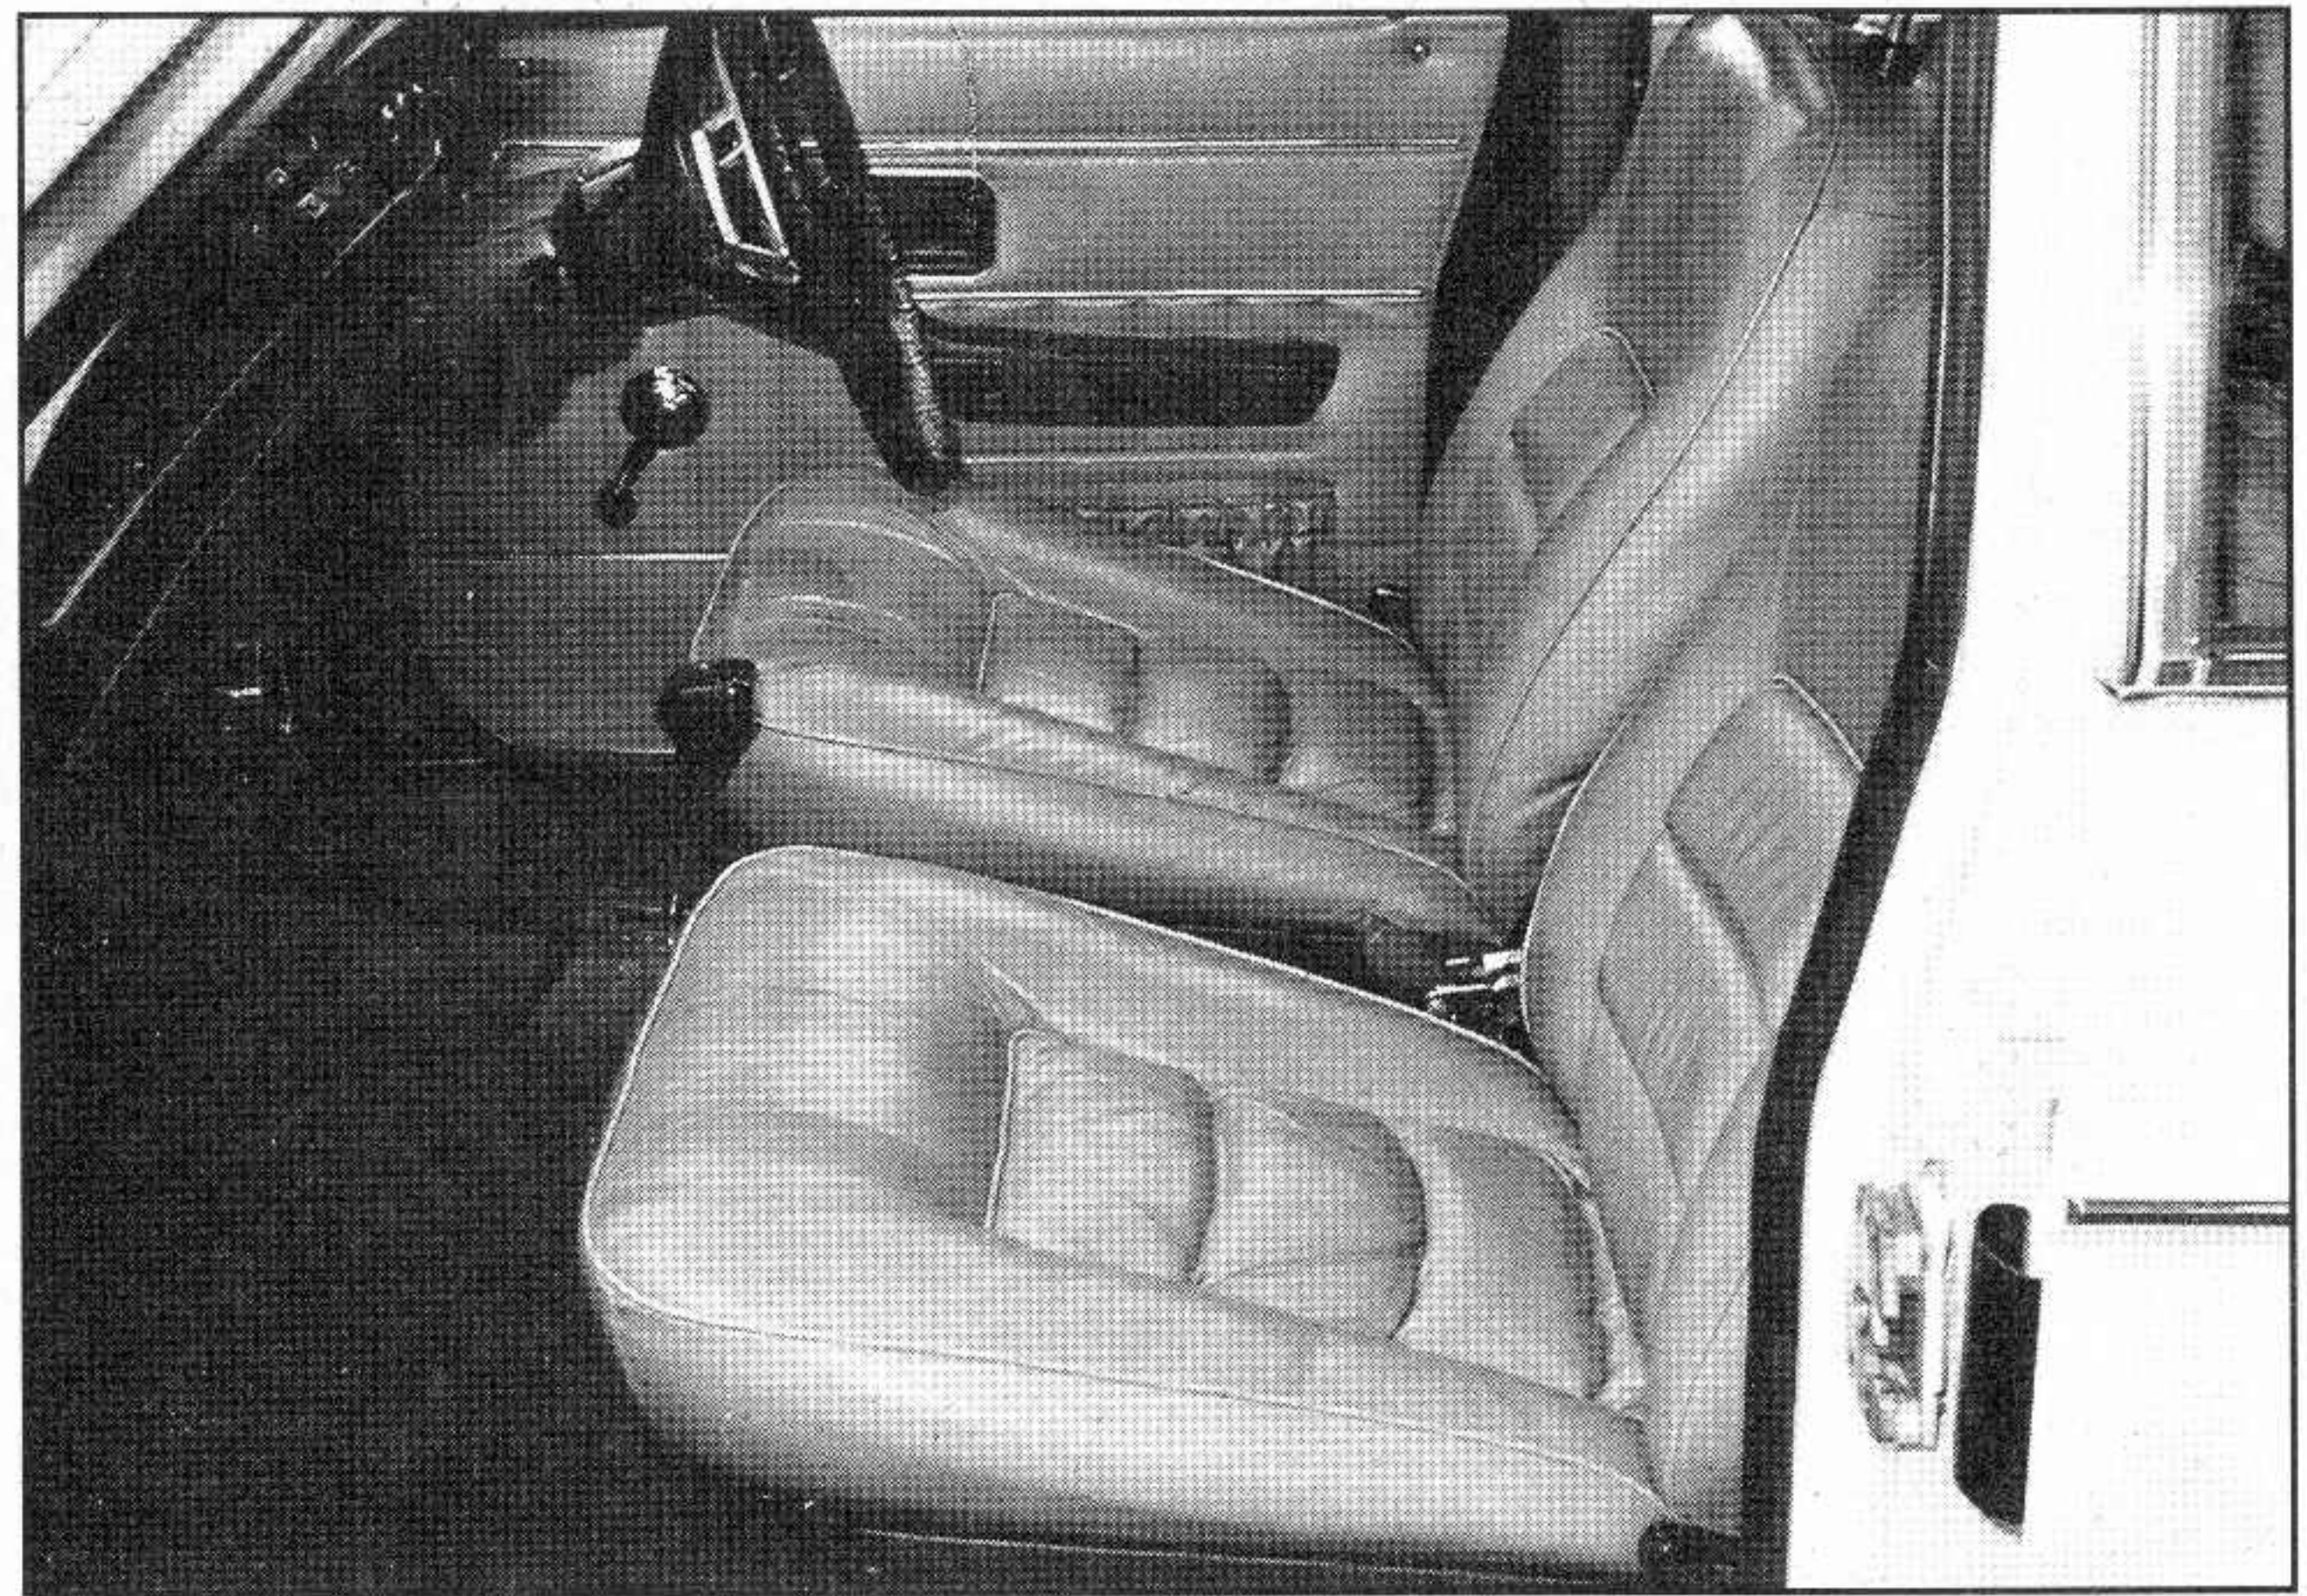
Careful attention to the leather with a Connolly Bros renovation kit meant that the 'just-painted' look was avoided. Paint for the leatherette door panels came from Woolies

Next, attention was turned to the interior trim, the seats were in a sorry state, the pale-blue dye had worn completely through revealing the tan hide. To remedy this I bought a leather renovation kit (sending a snippet of leather from the underside of the rear seat for colour matching) from Connolly Bros Ltd.

This comprised of one litre of dye, a half-litre of concentrated cleaner, a jar of hide food and a small roll of stockinette. The leather seat facings were fairly dry and stiff, so first I had to clean them and then apply hide food, leaving them for 24 hours, after which time the leather

became soft and supple. They were then cleaned again to remove any excess hide food, the leather was then ready for the application of the dye. This was done by dipping a swab of stockinette into the dye, applying evenly and sparingly to the leather to avoid that 'just painted' look, which would have ruined the whole appearance. Once completed the transformation to the interior was incredible.

A similar treatment was given to the door panels and other leatherette trim, the paint for these I obtained from "Woolies", this too had to be carefully applied to prevent 'tell-tale' brush marks. With the interior trim refinished I set about carefully fitting it back into the car.

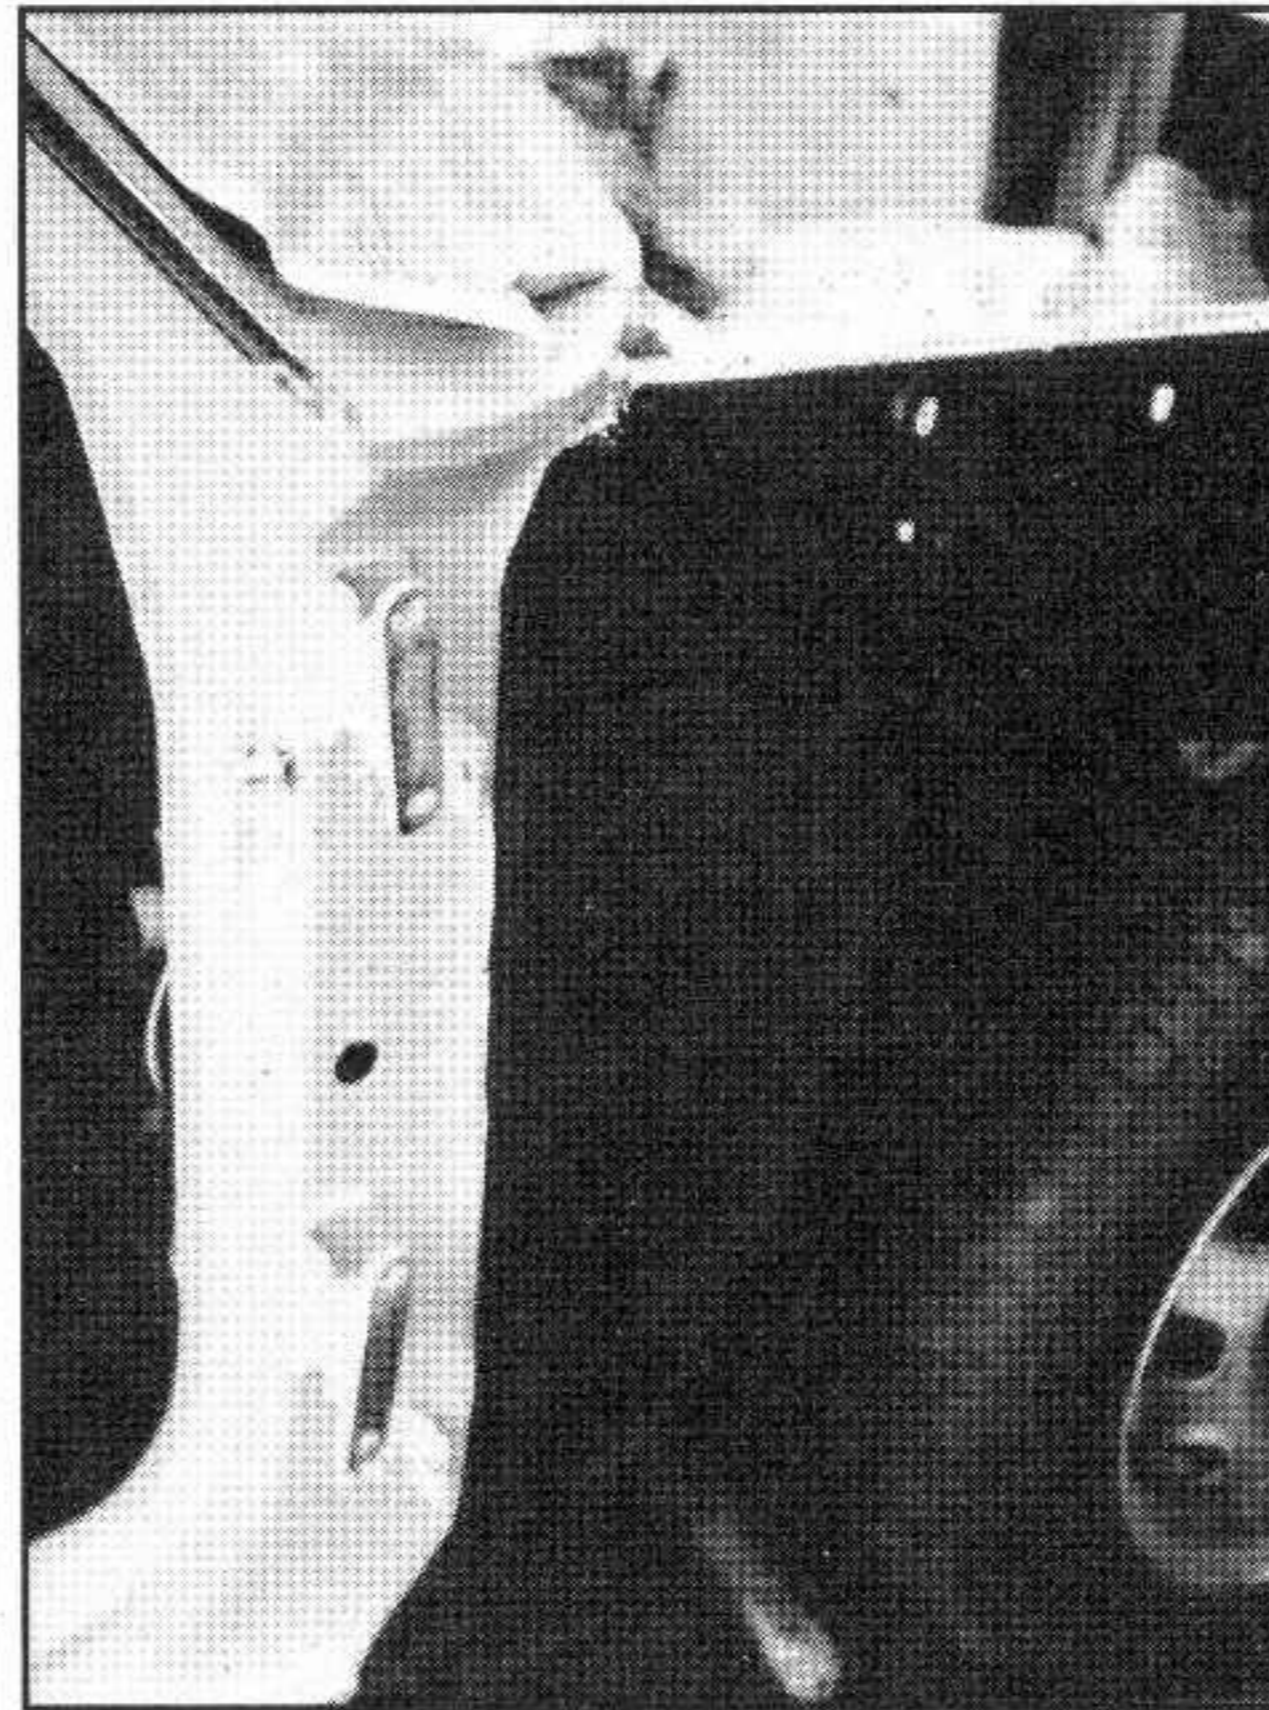
*Left, a view of the offside door post and inner wing with the front wing removed.*

Next I removed the front wings enabling me to gain access to the inner wings properly, it also made visible a rather ominous hole on the off-side of the lower scuttle, with a similar hole on the near-side. I removed all the underseal

from this area using a power wire-brush to cut out surface rusting. The area of severe rust was cut out and a plate welded in to strengthen the area. Coating first with Bonda primer, then Hammerite and underseal to protect from further rust attack.
