Installation Instructions

REAR LOUDSPEAKER AMPLIFIER

FOR RADIO MODELS: CR-712, CR-4123, CR-3183

VOLVO 240

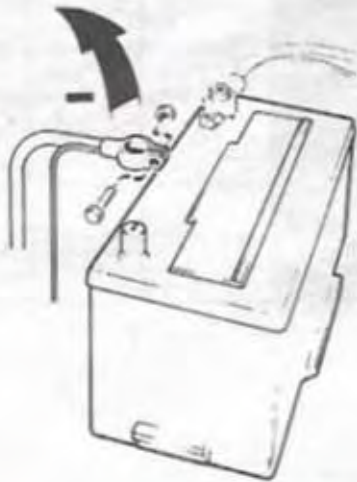
1

- Disconnect the negative terminal from the battery.

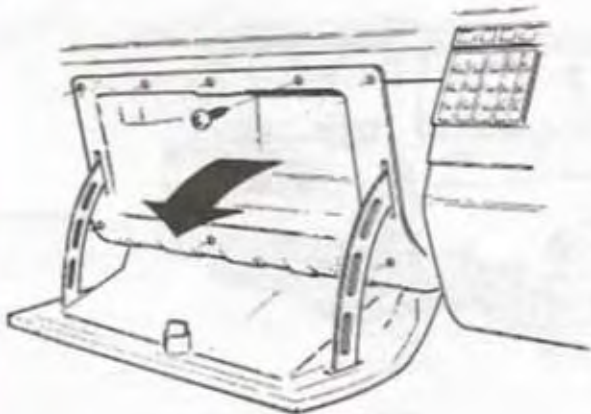
3

- Remove the glove compartment.

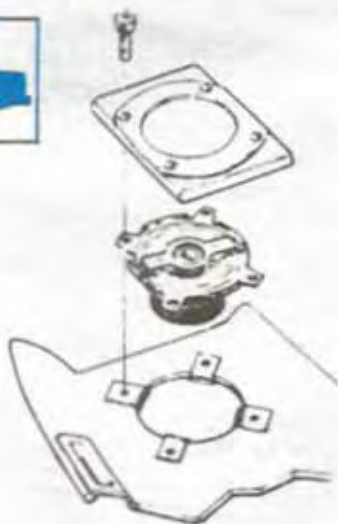
10

- Install the loudspeaker and the grille.
- Install the other loudspeaker in the same manner.

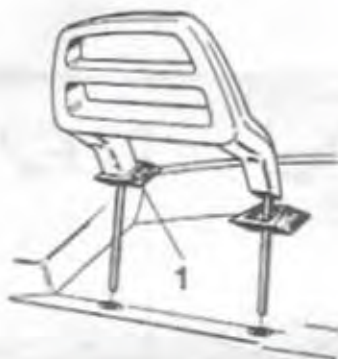
- Trim the back of outer headrest post foot (1) to be flush with post, repeat for left side.
- Reinstall head restraint, being certain it is locked into position.

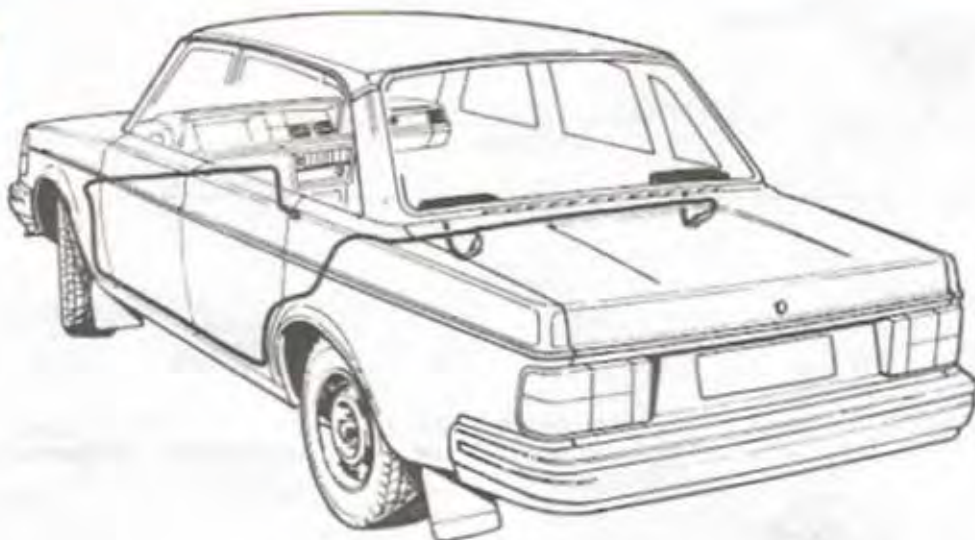
12

- Connect loudspeaker cable, Part No. 1129468-3.
- Attach the cables from the loudspeakers to the shelf with clips.
- Fold away panels, mats, etc. and route the loudspeaker cable to the radio compartment.

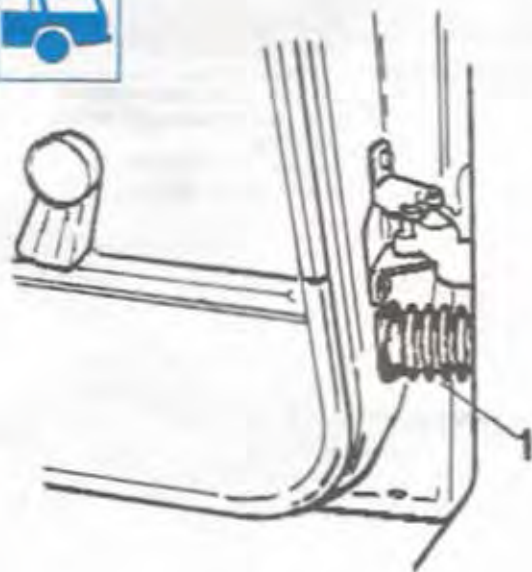
14

- Loosen the plastic cover (1), and route the speaker lead into the door cavity.

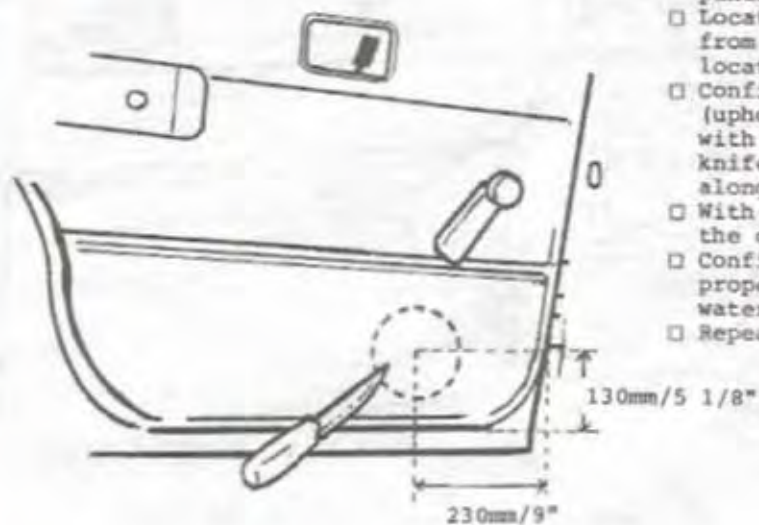
15

- For best results, remove rear door panel.
- Locate the door panel perforation from the rear side (approximate location shown on drawing).
- Confirm location from the front side (upholstered side) pressing firmly with finger tips. Using a sharp knife, carefully cut the cloth/vinyl along the perforation.
- With the cloth removed, cut through the door panel along the perforation.
- Confirm rain guard is positioned properly to protect speaker from water. Reinstall panel.
- Repeat procedure for right rear door.

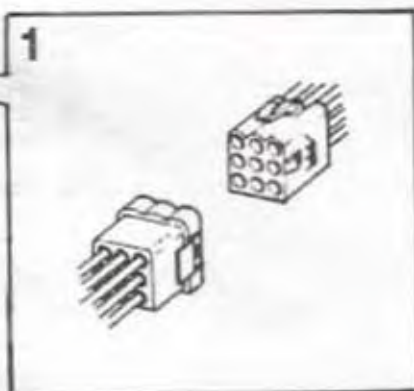
18

- Remove the screws and pull out radio.
- Separate the connectors (1).
- Route cables from amplifier to radio box.

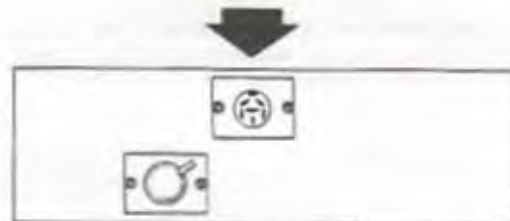
CONNECTION ON BACKSIDE OF RADIO

CR-3183

CR-4123

□ The arrow indicates the location for the amplifier DIN plug on each of three radio chassis.

CR-712

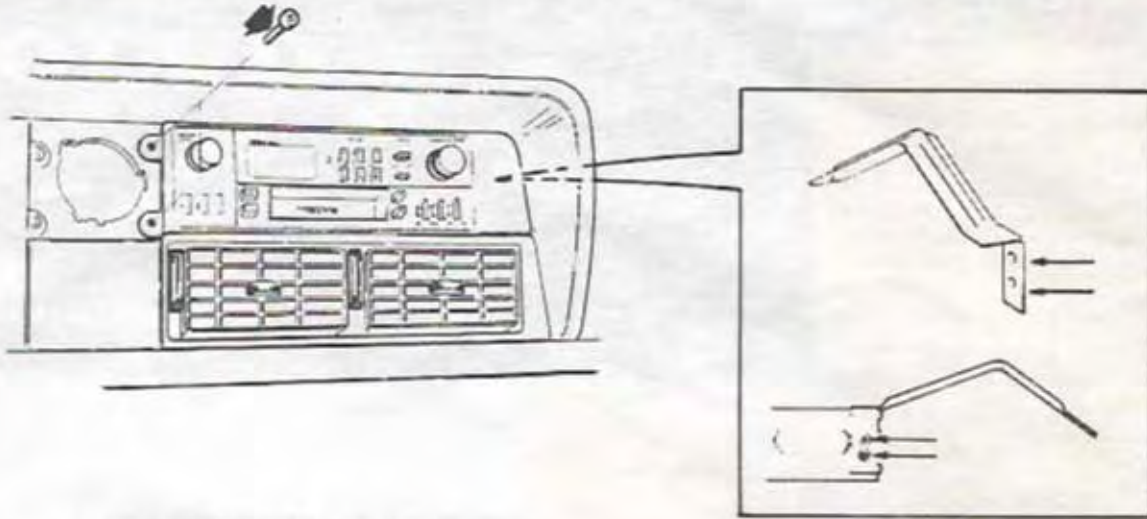
21

Reinstall the radio.
