<b>Reference Bulletins:</b>	<b>Subject:</b>	<b>Product</b>
SB 81-102; Aug. 1988	<b>SUNROOF</b>	<b>CARS</b>
	200	<b>Group</b>
	ALL	83
	<b>Date:</b>	<b>No.</b>
	AUGUST 1989	201

THIS BULLETIN APPLIES TO THE U.S. AND CANADA  
REFERENCE: TP 31120/1 (ENGLISH); BODY

Leakage from the left and right guide rails, and the two front rails, can be corrected using the following procedure. (To remedy the situation, the sunroof and guide rails must be removed.)  
The sealers to be used are butyl tape (P/N 1277872-6), plastic filler (P/N 1161123-3), and body filler (P/N 277253-1).

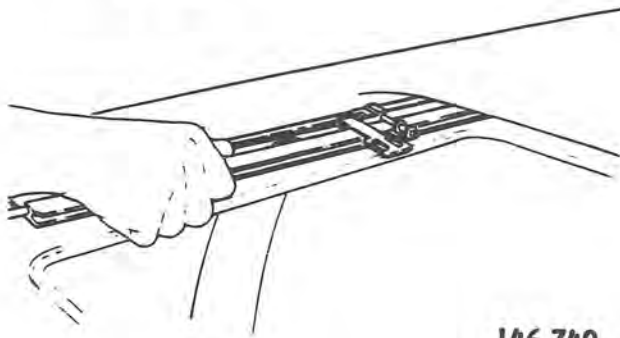
**Note:** Guide rails may be stuck in place due to butyl tape in drain channel.

**Remove guide rails on both sides**

**Pull guide rails straight out**

**Important:** Carefully remove all butyl tape remaining in guide rails

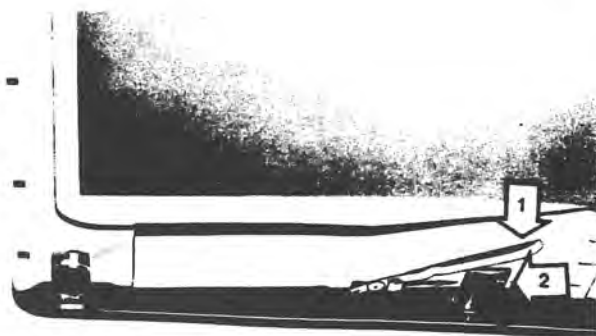
**Note:** Make sure wind deflector connecting arms (arrow) are correctly positioned between roof and base plate. Water leakage could result if arms contact roof or base plate.

**Install sunroof**

Make sure reinforcing plates (2) for rear mounts are correctly positioned.
